# Manhole Inspection Summary

Manhole # S13AA1024MH

Insp Date: **1/26/09 10:50 AM**

**Location** Address: **2914 VIOLET AVE**

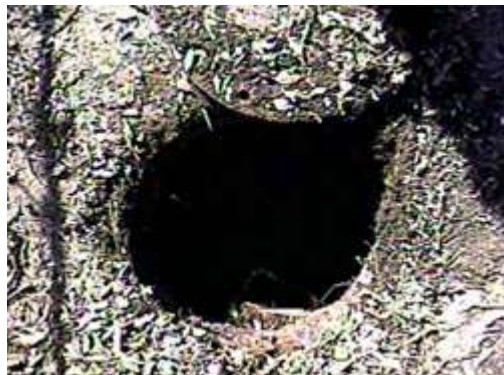
Top View

**Frame** Offset: **4** (in.) Condition: ☐ Sound ☐ Cracked ☒ **Leaks**

FRAME OFFSET

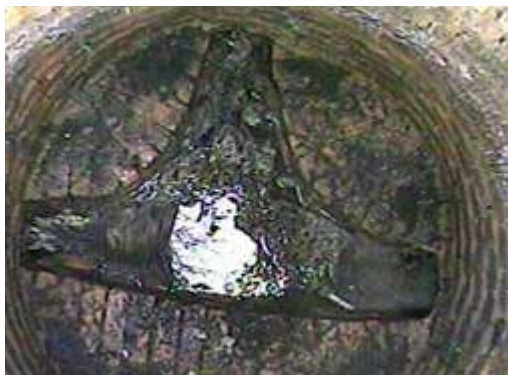
Top View

BENCH DEBRIS

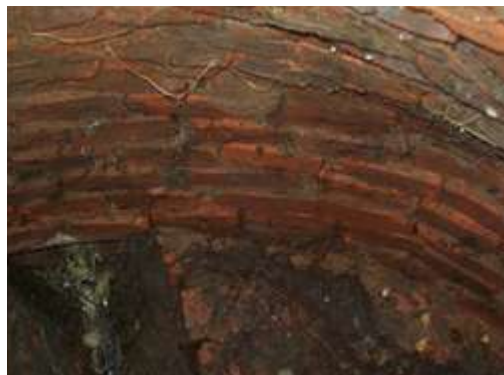
Defect 3

Condition: ☐ Sound ☐ Cracked ☒ **Root Intrusion** ☐ Loose Brick ☐ Deteriorated

Infiltration: ☐ None ☐ Joint ☐ Cracks ☐ Mortar ☒ **Roots** ☐ Wall

Barrel Root Intrusion

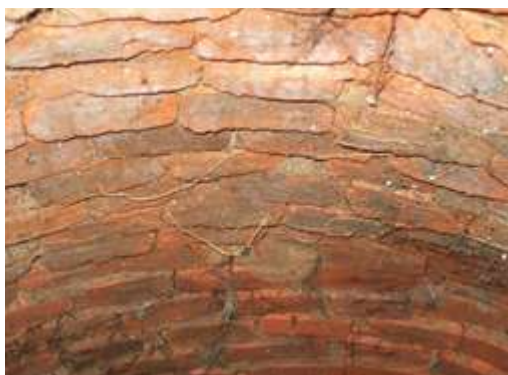
Defect 2

Condition: ☐ Sound ☐ Cracked ☒ **Root Intrusion** ☐ Loose Brick ☐ Deteriorated

Infiltration: ☐ None ☐ Joint ☐ Cracks ☐ Mortar ☒ **Roots** ☐ Wall

Corbel Root Intrusion

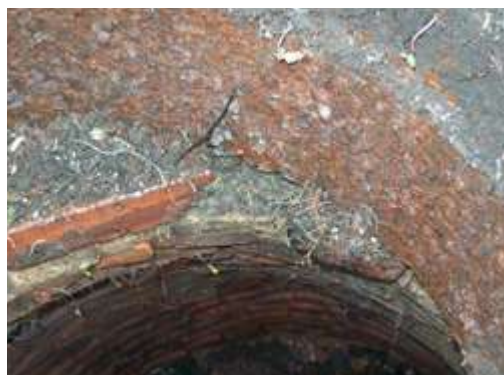
Defect 1

Condition: ☐ Sound ☐ Cracked ☒ **Root Intrusion** ☐ Loose Brick ☒ **Deteriorated**

Infiltration: ☐ None ☐ Joint ☐ Cracks ☐ Mortar ☒ **Roots** ☐ Wall

Chimney Root Intrusion and deterioration

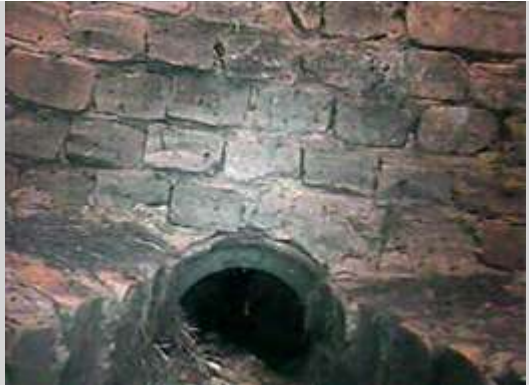
12 O'Clock Outflow

Pipe Height: (in.) Direct  
Pipe Material: **Clay** ☐ Pipe Lined  
Invert Depth: **6.10** (ft.) Flow Characteristics: **Slow**  
Deposits: ☒ None ☐ Mud ☐ Sludge ☐ Debris ☐ Grease  
Silt Depth: (in.) Deposits Extent:  
Infiltration: **None** Pipe Seal Cond: **Sound**

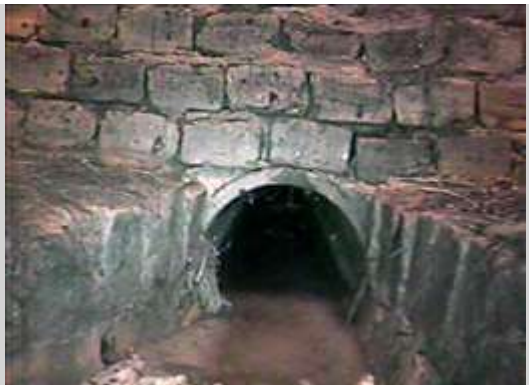
3 O'Clock Inflow

Pipe Height: (in.) Direct  
Pipe Material: **Clay** ☐ Pipe Lined  
Invert Depth: **5.95** (ft.) Flow Characteristics: **Slow**  
Deposits: ☒ None ☐ Mud ☐ Sludge ☐ Debris ☐ Grease  
Silt Depth: (in.) Deposits Extent:  
Infiltration: **None** Pipe Seal Cond: **Sound**

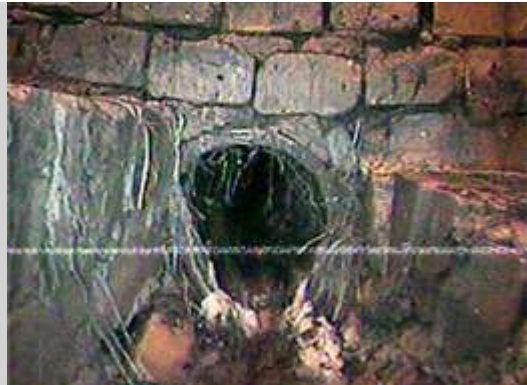
9 O'Clock Inflow

HEAVY ROOT INTRUSION IN ENTIRE MH.
